# Manhole Inspection Summary

Manhole # S29SS1007MH

**Inspection** ☐ Is Incomplete Rating: **3) Fair**

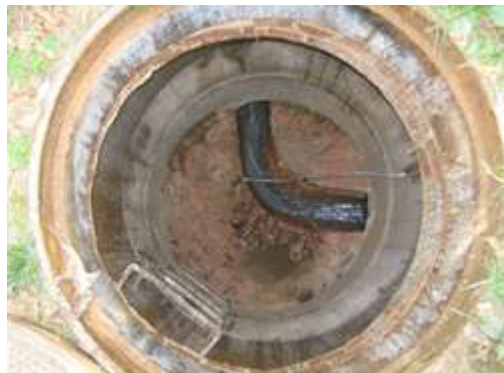
Evidence of surcharge - Bench debris.

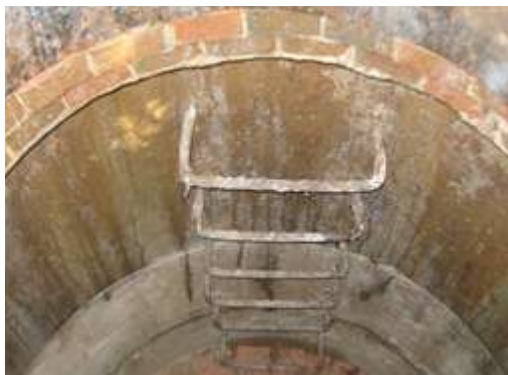
Defect

Corbel and Barrel infiltration.

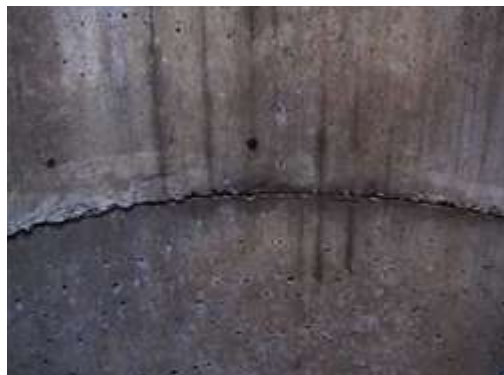
Defect

Barrel infiltration.

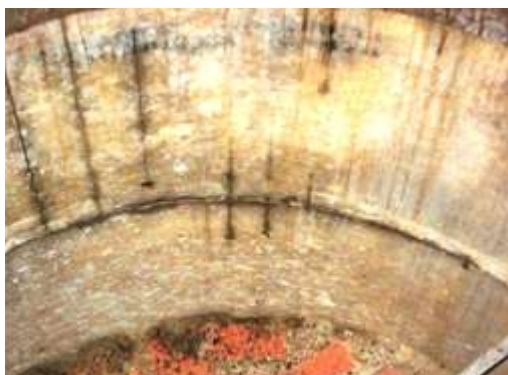
Defect

Corbel and Barrel infiltration.

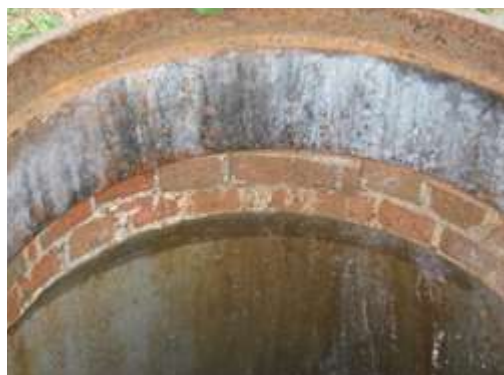
Defect

Adjustment and Corbel infiltration.

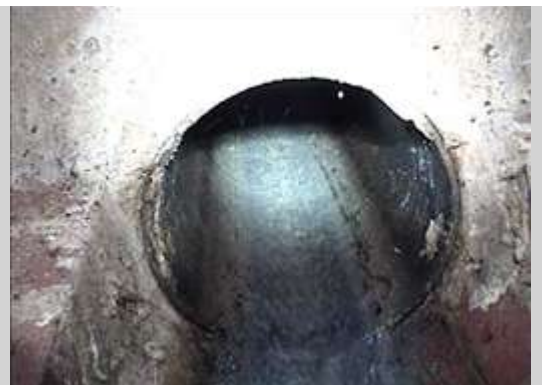
Pipe In @ 4 O'Clock

Infiltration: **Evidence** Pipe Seal Cond: **Unknown**
